CENTERVILLE BEACH SPLIT
PIPE REPAIR

Ocean Engineering

CHESAPEAKE DIVISION
NAVAL FACILITIES ENGINEERING COMMAND
WASHINGTON NAVY YARD
WASHINGTON, DC 20374

1977

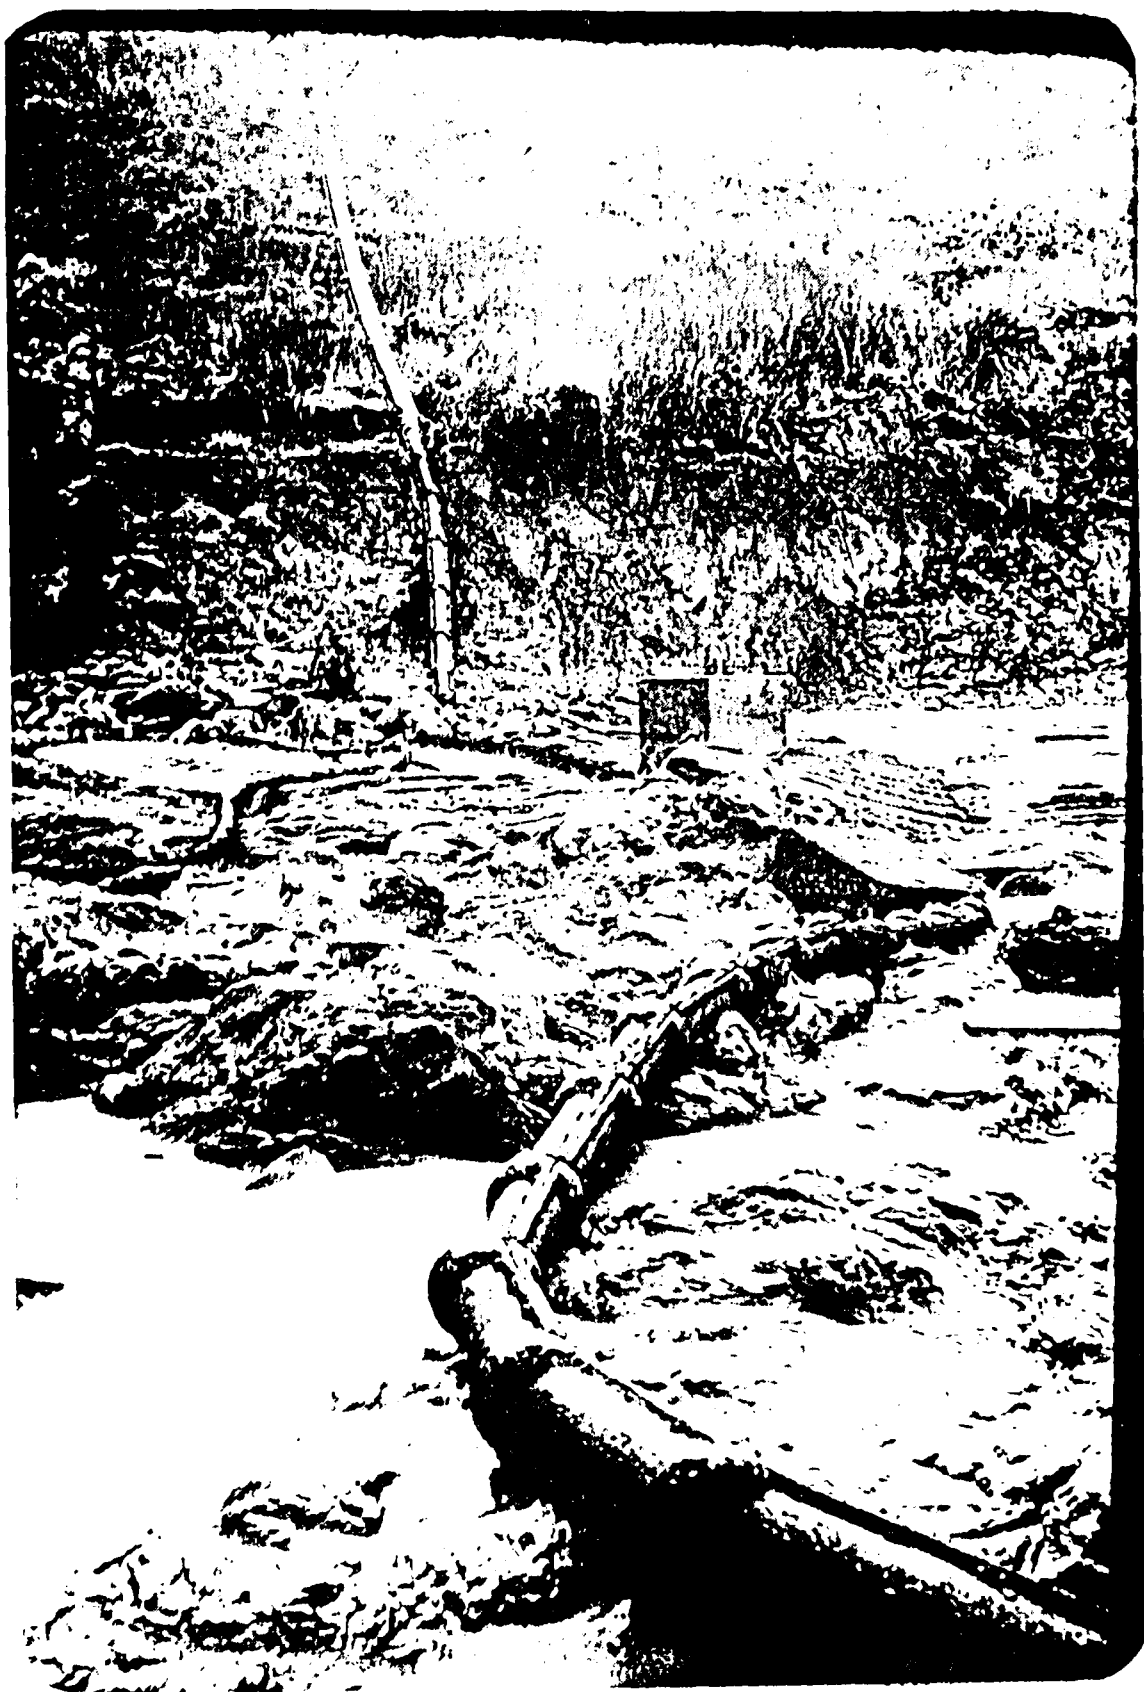
FIGURE 3. South Cable on Beach

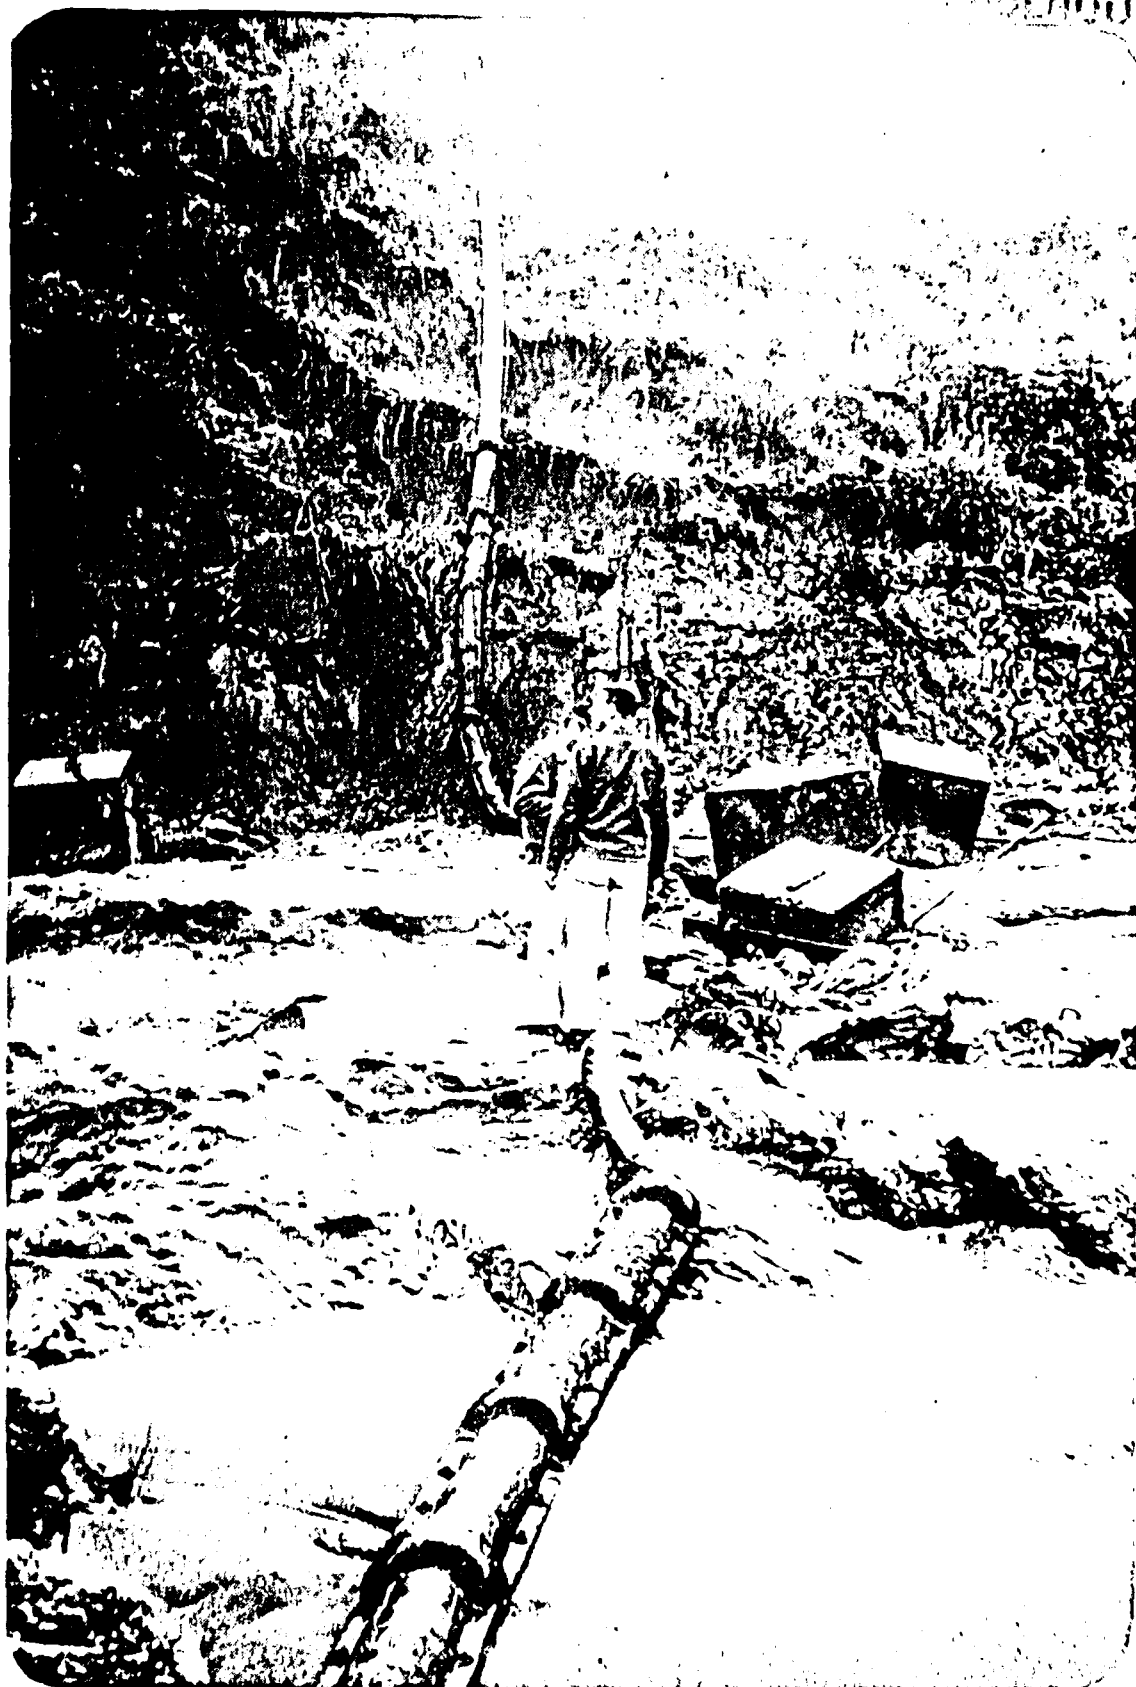
Figure 6. North Cable on Beach

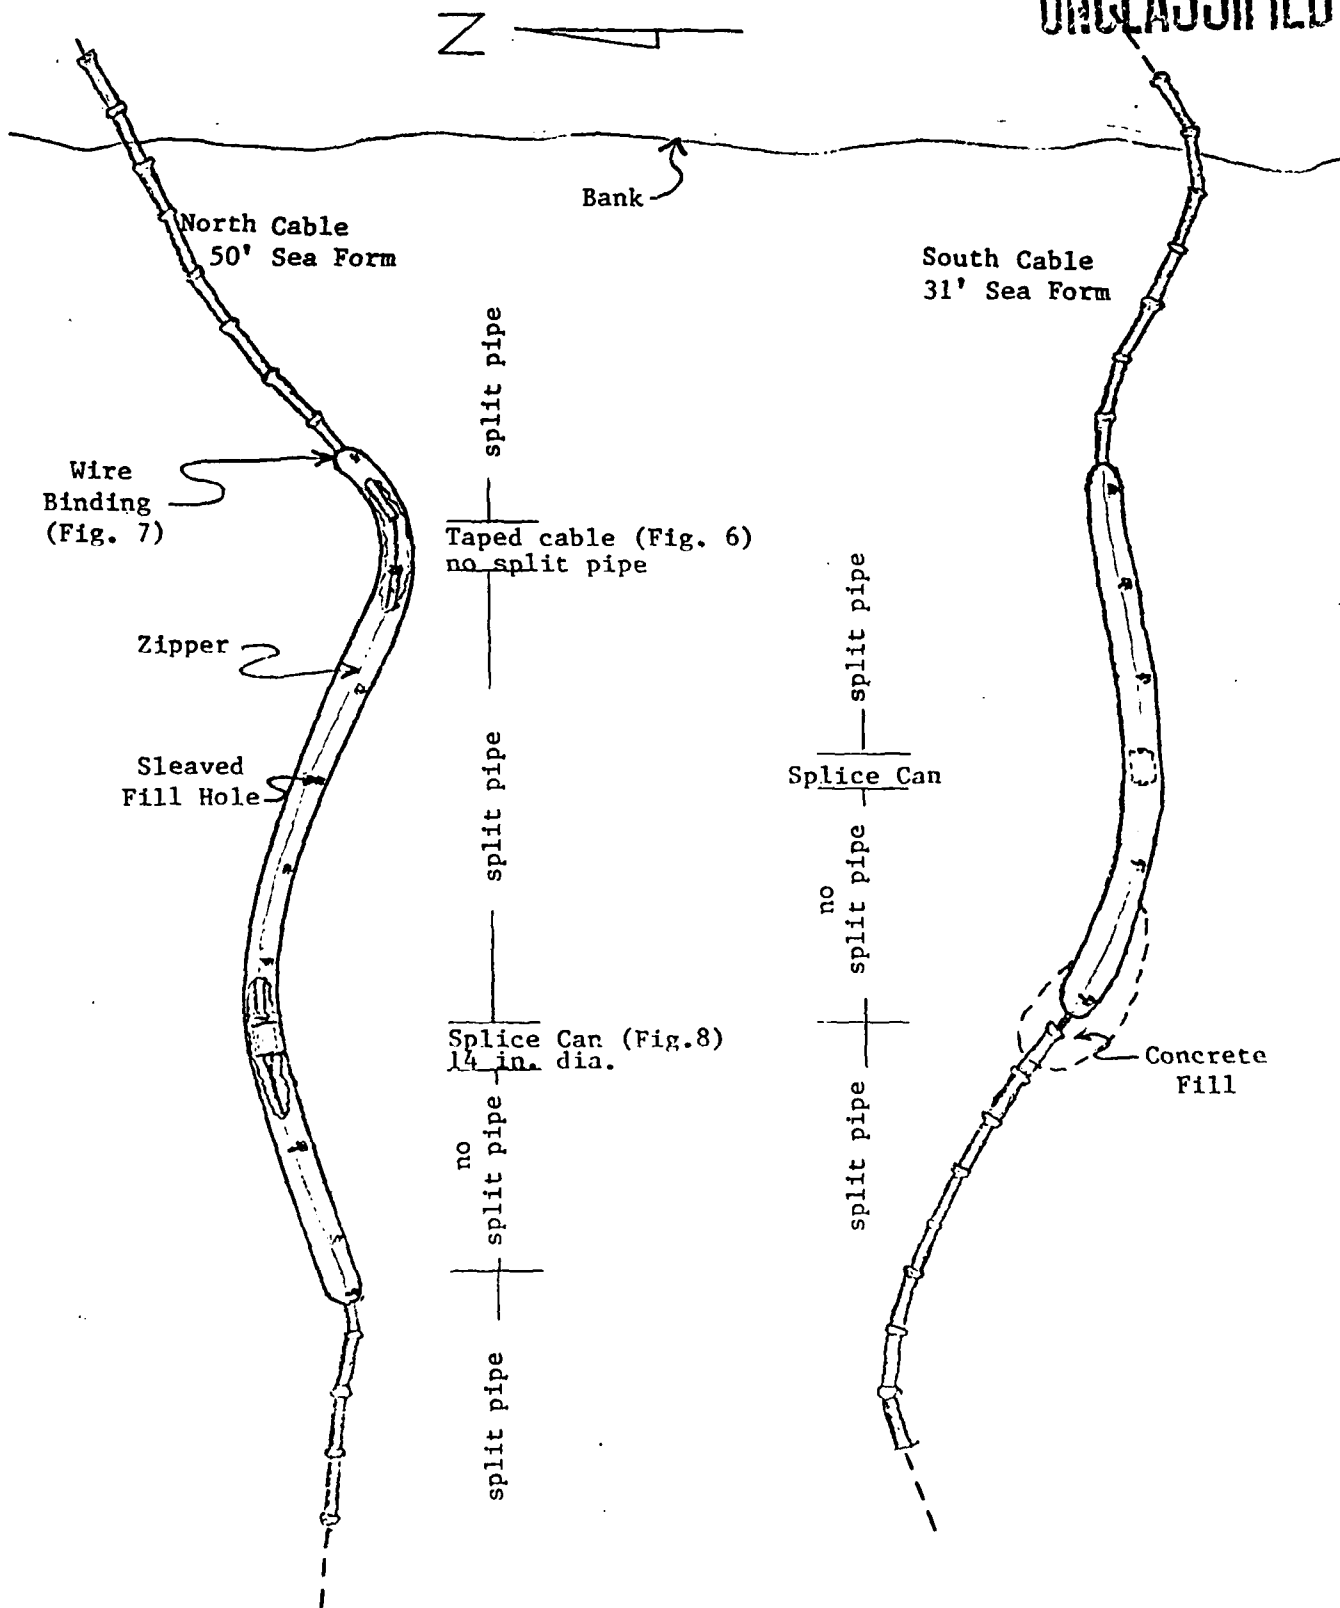
Figure 7. Cable Repair Layout

(U) As a more permanent repair, it was proposed to splice new cable around the damaged sections of both systems. Investigation of this proposal soon revealed that such a cable splicing operation would take nearly two months to prepare, including the fabrication and shipment of the required cable. Since any significant time delay could have caused an increase in the cable damage, the bypass splice had to be ruled out. It was therefore proposed jointly by UCT-2 and CHESNAVFACENGCOM that a modified application of the "Sea Form Systems" method (Appendix B) for pier piling protection be used. The "Sea Form" method was developed for protecting deteriorated pilings by incasing the piling in concrete. This system was adapted to protect the damaged cables. See Figure 7.

(U) The damaged sections of the two cables were successfully protected and stabilized using the "Sea Form System" to incase the vulnerable cable in concrete (Figure 7). Each repair section started out about 20 feet from the bank with the Sea Form nylon bag tied by wire around the bell of a split pipe section. The forms were 18 inches in diameter (56 inch circ.) with the cable centered inside. The splice cans connecting the shoreward and seaward legs of the cables were approximately in the middle of each form. Steel rebar was layed through the form to strengthen the form and rebar was driven through the bottom of the bag a few feet into the mudstone in order to anchor the form. Although the same system was used on both cables there were minor differences in what was installed.

(U) The south cable repair section was 31 feet long approximately 30 feet south of the north cable. The nylon bag was one split pipe section short of incasing the seaward leg of the split pipe (Figure 7). For this reason, 0.5 cubic yards of concrete were poured around the seaward end of the bag and cable to structurally bridge the form to the pipe. This cable was buried after the form was completely installed.

(U) The north cable repair was 50 feet long incasing both the seaward and shoreward legs of split pipes. There was a four foot section of taped cable (without split pipe) that was incased in the shoreward end of the form (Figure 7). This cable was left to be buried by the surf. See Figure 14.
